Inspection report

Date: 28/06/2011	Job N°: 2581	Weather: Dry	Operator: J GIBBS	section number: 2	PLR: F13A X
Present:	Vehicle: PRI 56	Camera: IPEK 1	Preset:	Cleaned: No	Grade:

Road: XXXXX	Division:	start MH: F13
Place: XXXXX	District:	end MH: F13A
Location: Difficult access	Tape No.: 2581	Total length: 16.1 m

Comment:
 Location details: **CAR PARK TO INSIDE STORE**

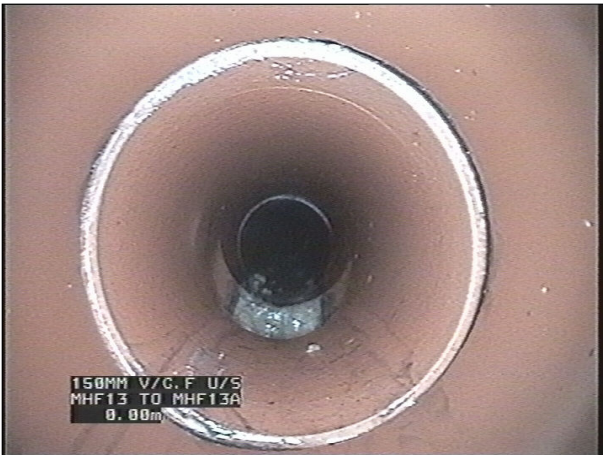
Photo: 10_1b, Tape No.: 2581, 00:18:15
 0m, Start of Survey

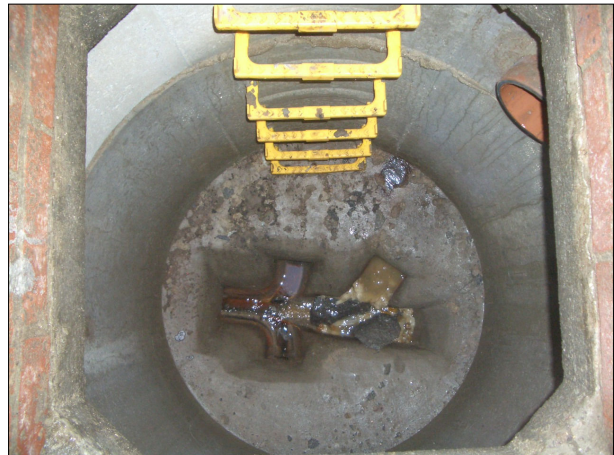
1:125	position	code	observation	counter	photo	grade
Depth: 0.94						
			F13			
	0.00	ST	Start of Survey	00:18:15	10_1b	(Misc) 0
	0.00	MH	manhole Remark:MHF13 (DEBRIS IN MANHOLE)	00:18:15	2_2a	(Constr) 0

Photo: 2_2a, Tape No.: 2581, 00:18:15
 0m, manhole Remark:MHF13 (DEBRIS IN MANHOLE)

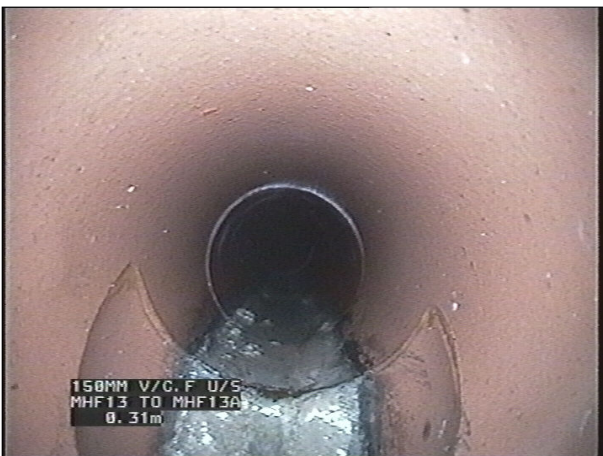
0.00	WL	Water level, 05 % height/diameter	00:18:15		(Serv) 0
	0.30	JN	Junction at 06 o'clock, dia 150 mm, Remark: BACK DROP INTO MHF13	00:18:22	13_4b	(Constr) 0

Photo: 13_4b, Tape No.: 2581, 00:18:22
 0.3m, Junction at 06 o'clock, dia 150 mm, Remark: BACK DROP INTO MHF13

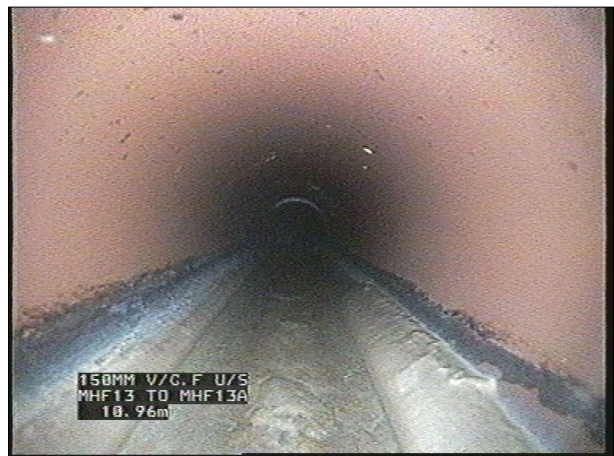
7.20	WL	Water level, 20 % height/diameter, Remark: INCREASE IN FLOW	00:19:58		(Serv) 0
	9.20	WL	Water level, 10 % height/diameter	00:20:30		(Serv) 0
	10.90	C1 DEG	Debris grease, from 05 to 07 o'clock, 10 % cross-sectional area loss, Changed	00:20:50	18_9a	(Serv) 1

Photo: 18_9a, Tape No.: 2581, 00:20:50
 10.9m, Debris grease, from 05 to 07 o'clock, 10 % cross-sectional area loss, Changed

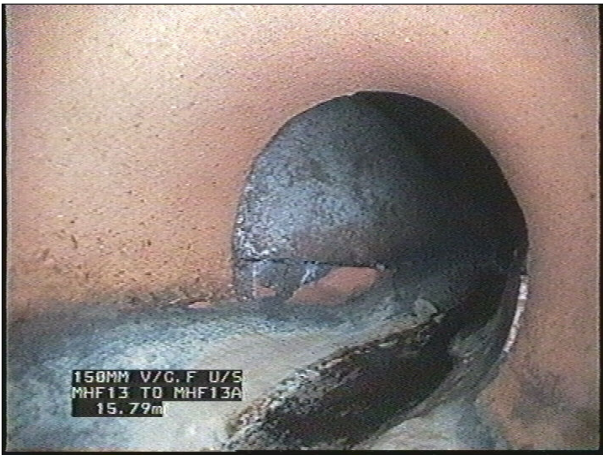
12.30	C1 DEG	Debris grease, from 05 to 07 o'clock, 05 % cross-sectional area loss, Changed	00:21:07		(Serv) 1
	15.70	LR	Line of Sewer deviates right, Remark: SLIGHT	00:22:07	22_13a	(Serv) 0

Photo: 22_13a, Tape No.: 2581, 00:22:07
15.7m, Line of Sewer deviates right, Remark: SLIGHT

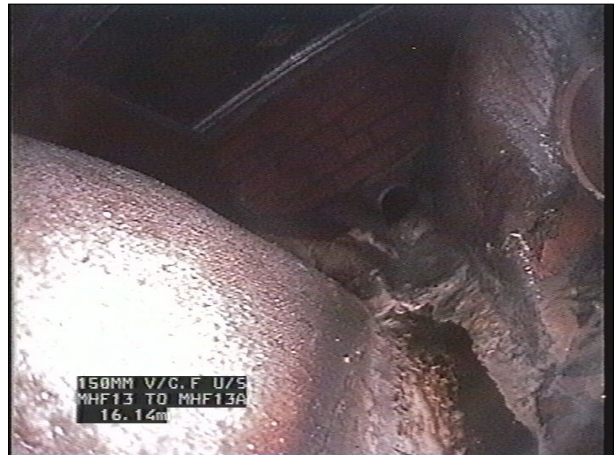
16.10	F1 DEG	Debris grease, from 05 to 07 o'clock, 05 % cross-sectional area loss, Finish	00:22:19		(Serv) 1
	16.10	MH	Manhole Remark: MHF13A, IN STORE IN TOILET BLOCK UNDER CUBICLE, UNABLE TO RAISE.	00:22:19	24_15a, b	(Constr) 0

Photo: 24_15a, Tape No.: 2581, 00:22:19
16.1m, Manhole Remark: MHF13A, IN STORE IN TOILET
BLOCK UNDER CUBICLE, UNABLE TO RAISE.

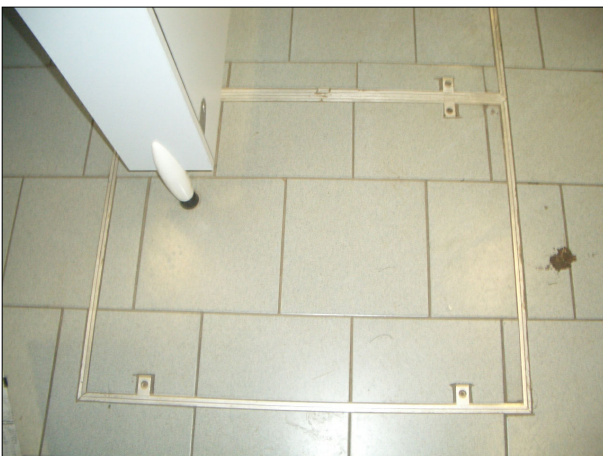
Photo: 2_15b, Tape No.: 2581, 00:22:19
16.1m, Manhole Remark: MHF13A, IN STORE IN TOILET
BLOCK UNDER CUBICLE, UNABLE TO RAISE.
